UltraThin Overlay in Platteville

November 29, 2016

Howard B. Crofoot, P.E.

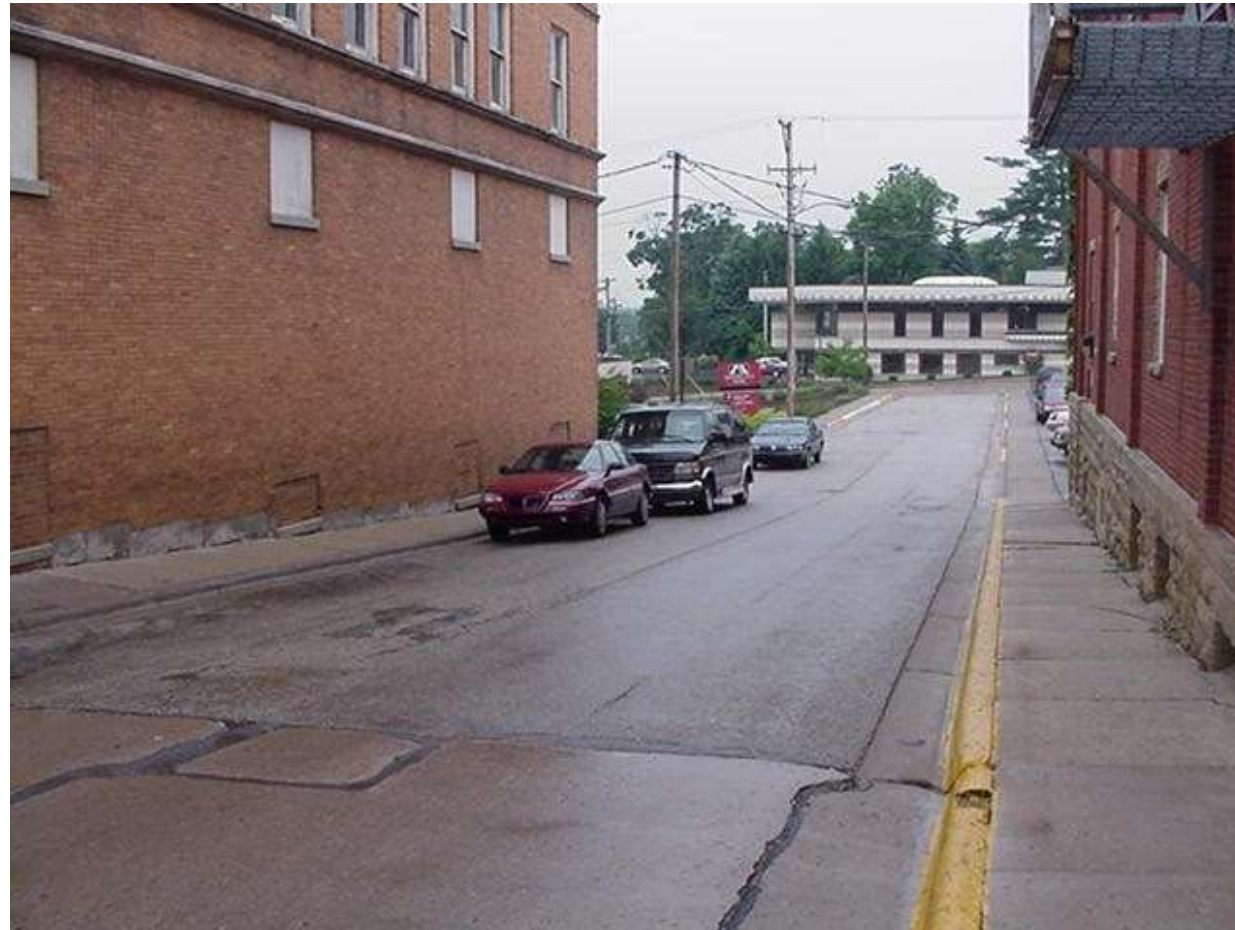
- Before photos: June 2, 2002 – looking south from Main Street

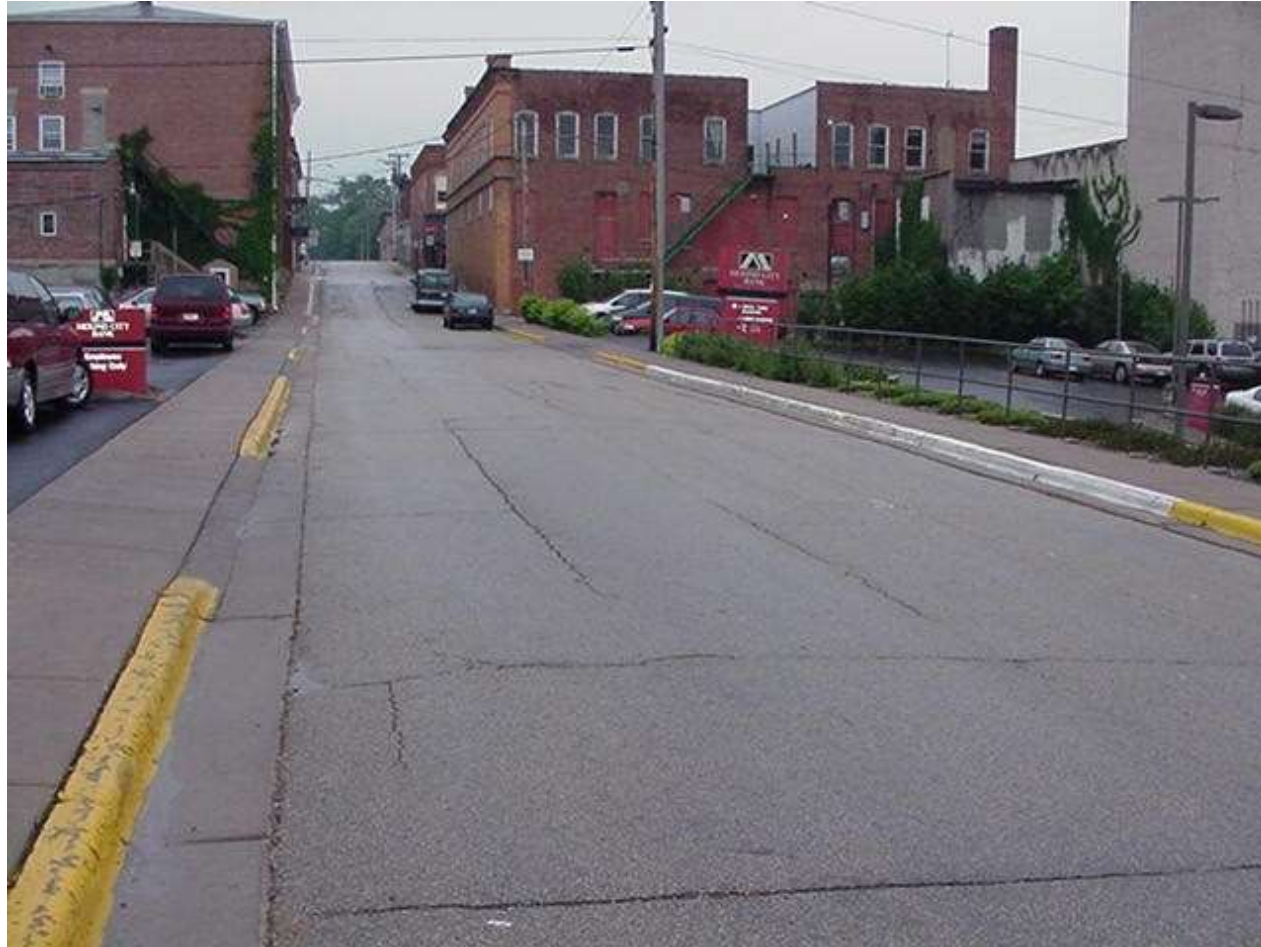
- Before photos: June 2, 2002 Looking north from Pine Street

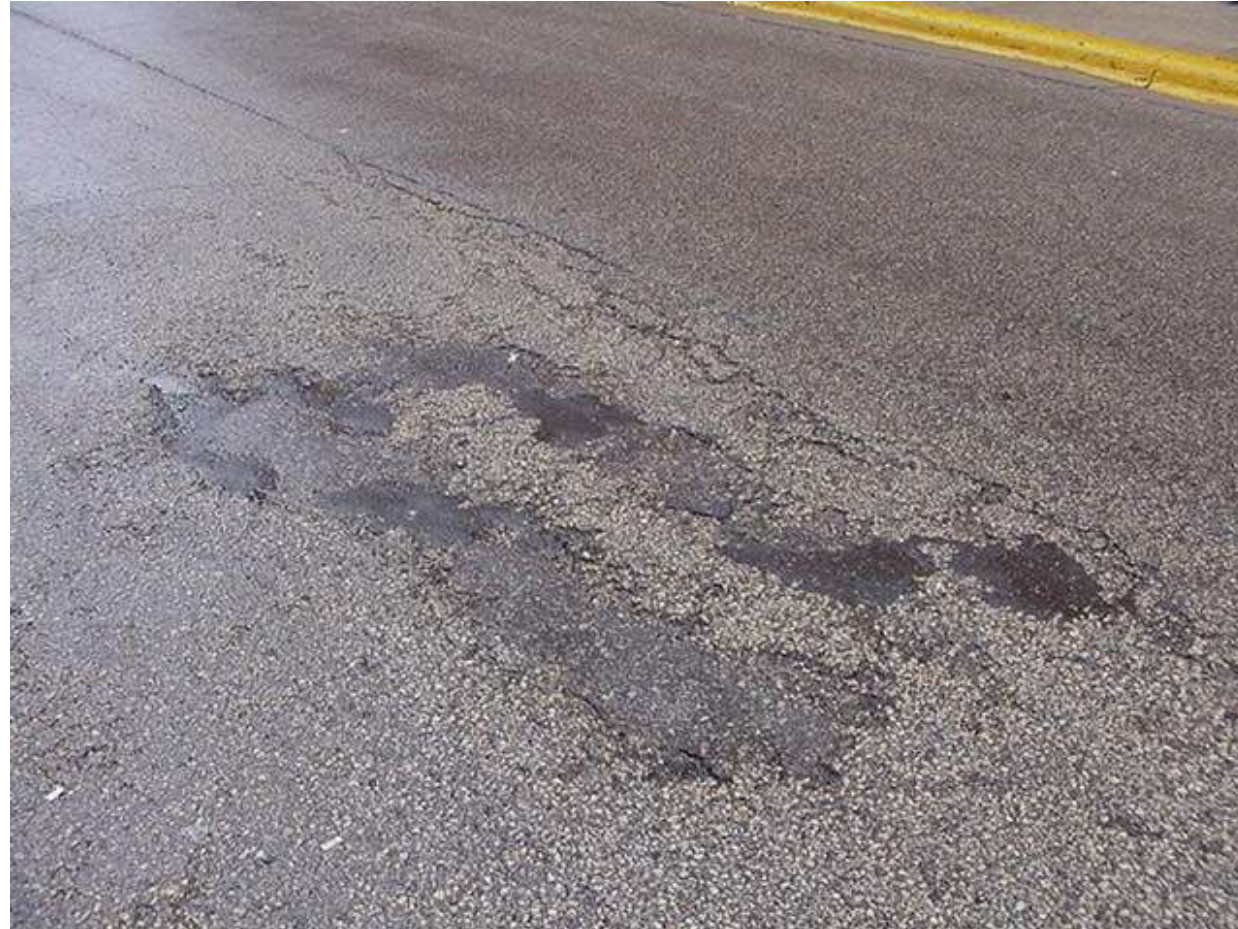
- Before photos: June 2, 2002 Close up of patching

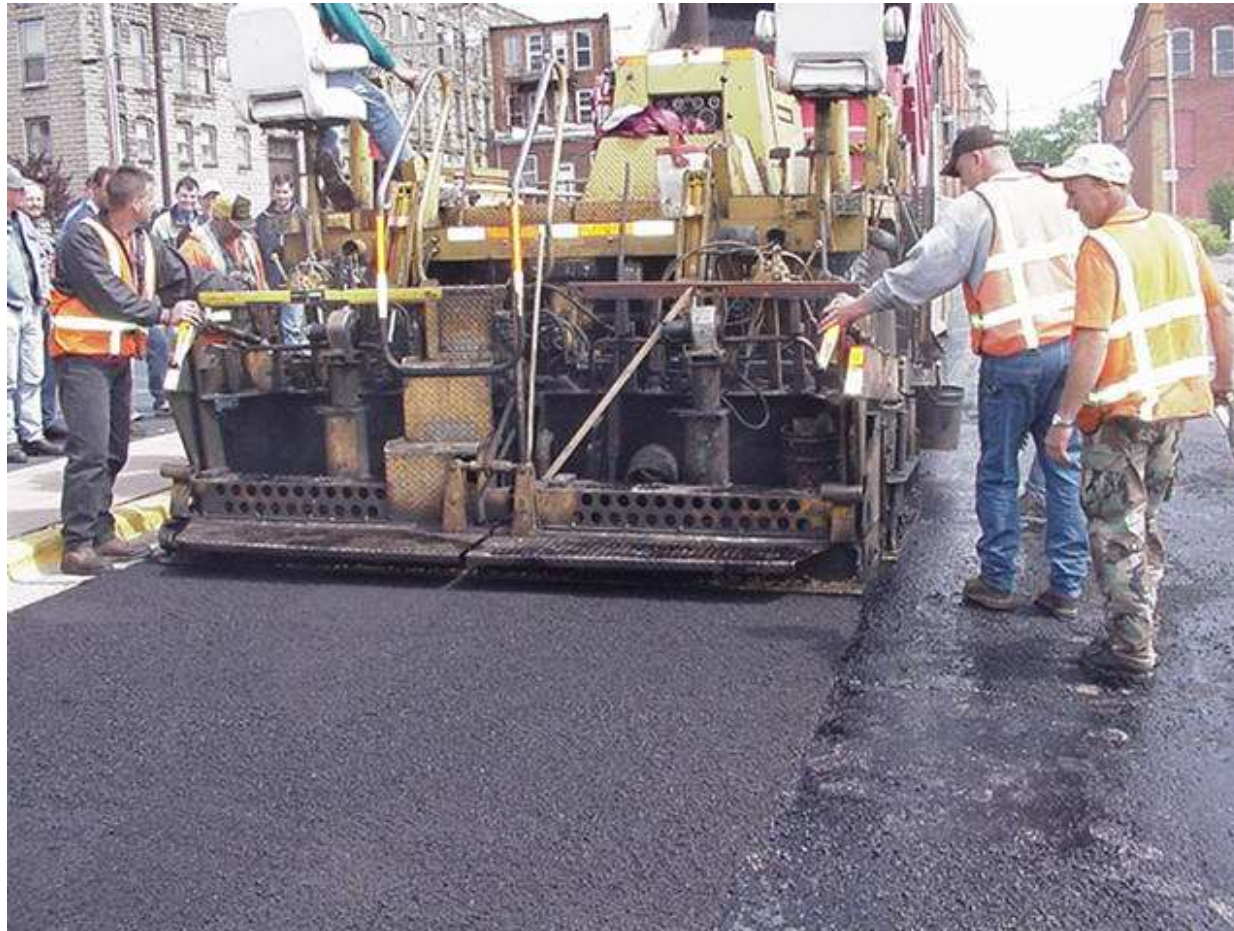
- During Photos: June 5, 2002 Milled edges and ends instead of feathering, tack coat on surface

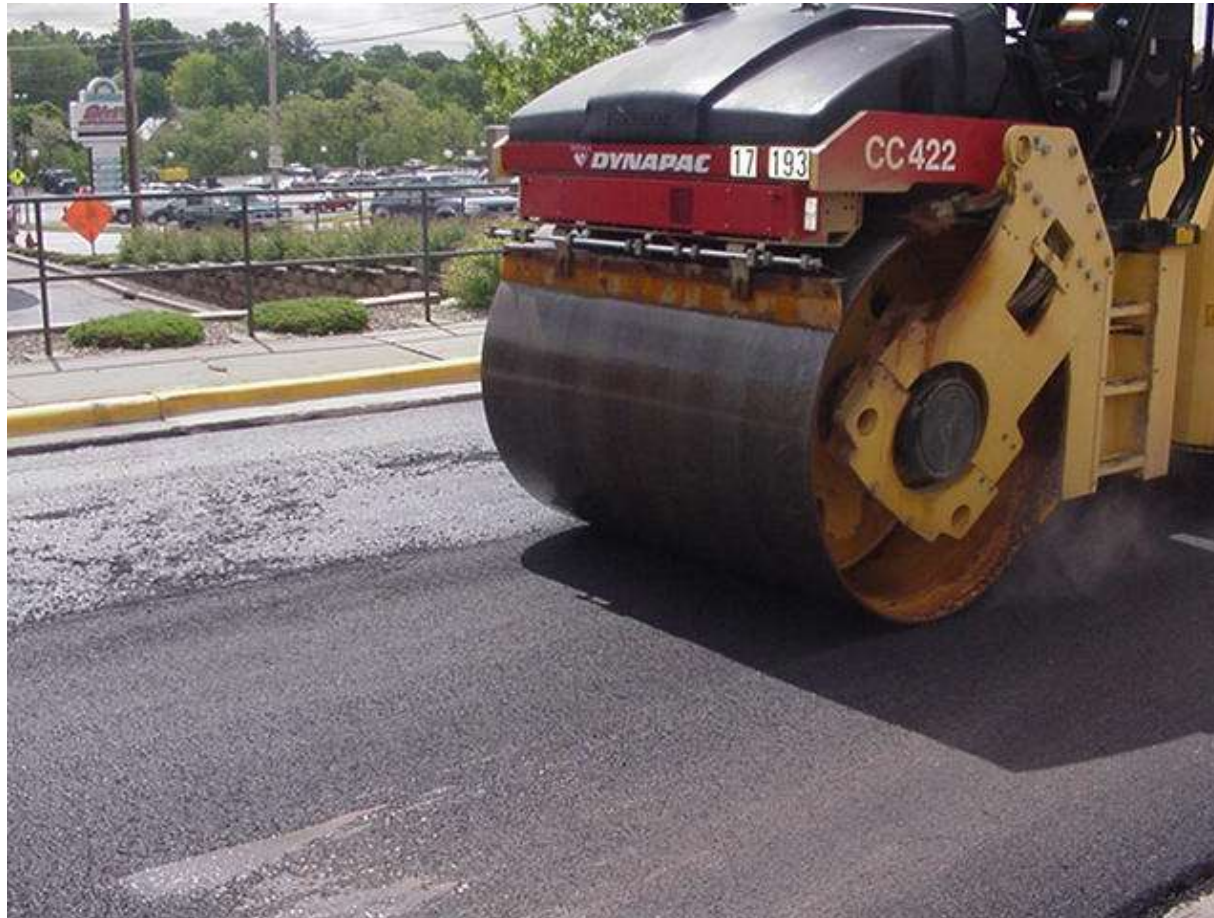
- During Photos: June 5, 2002 Rolled, but mix is more dense

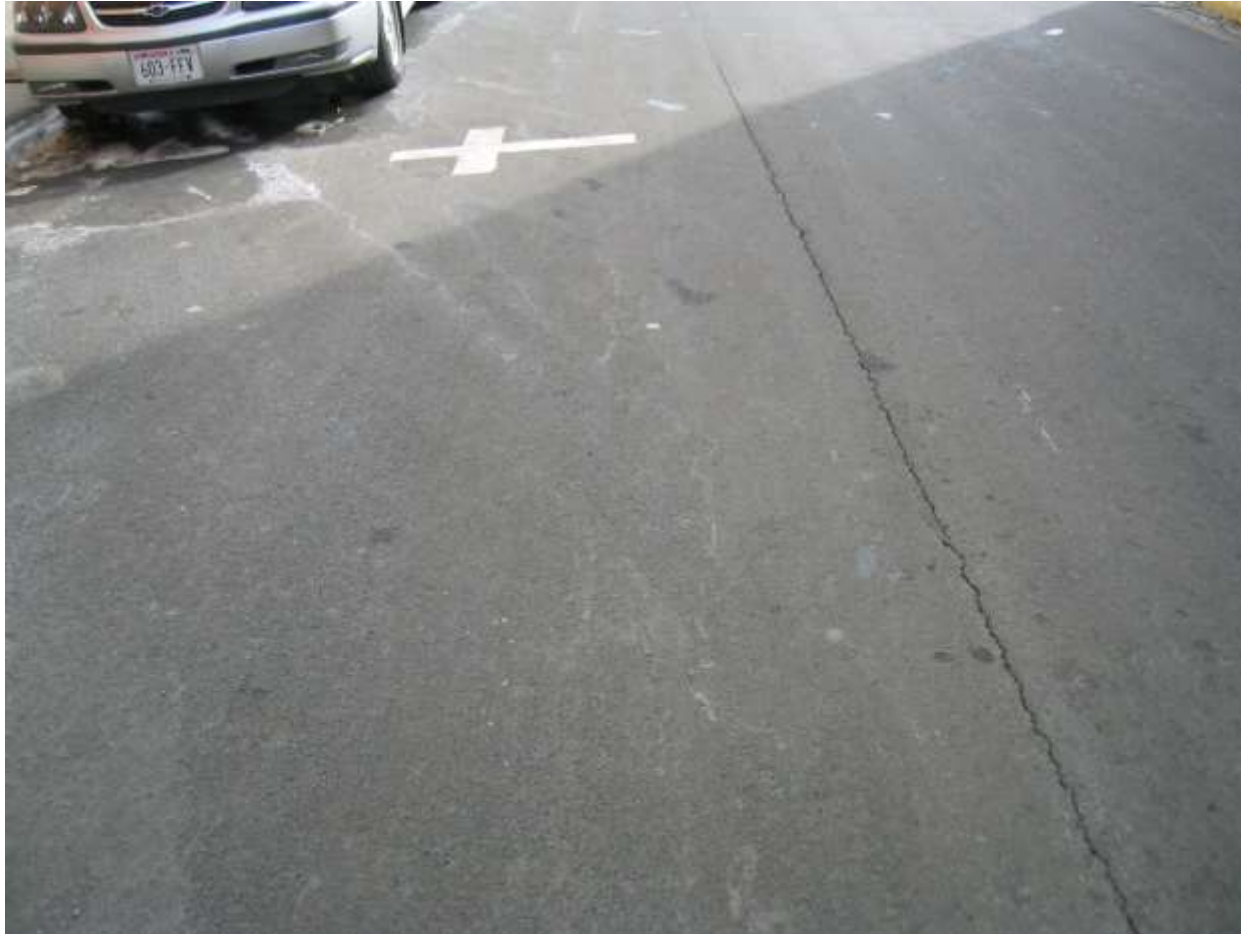
- After Photo: March 2003 - Reflective cracking visible

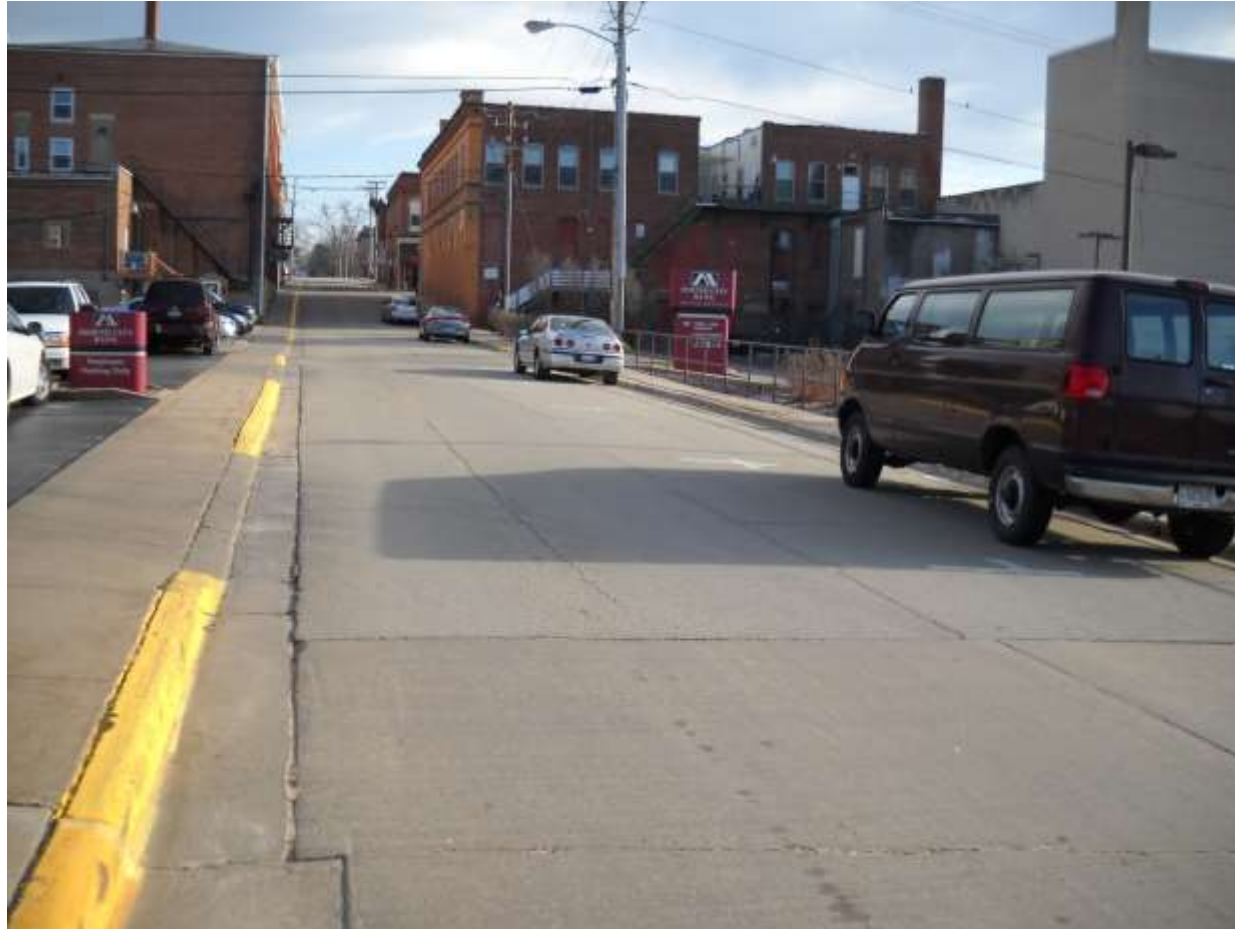
- After Photo: April 2010 – full reflective cracking, no sealing, ride still good

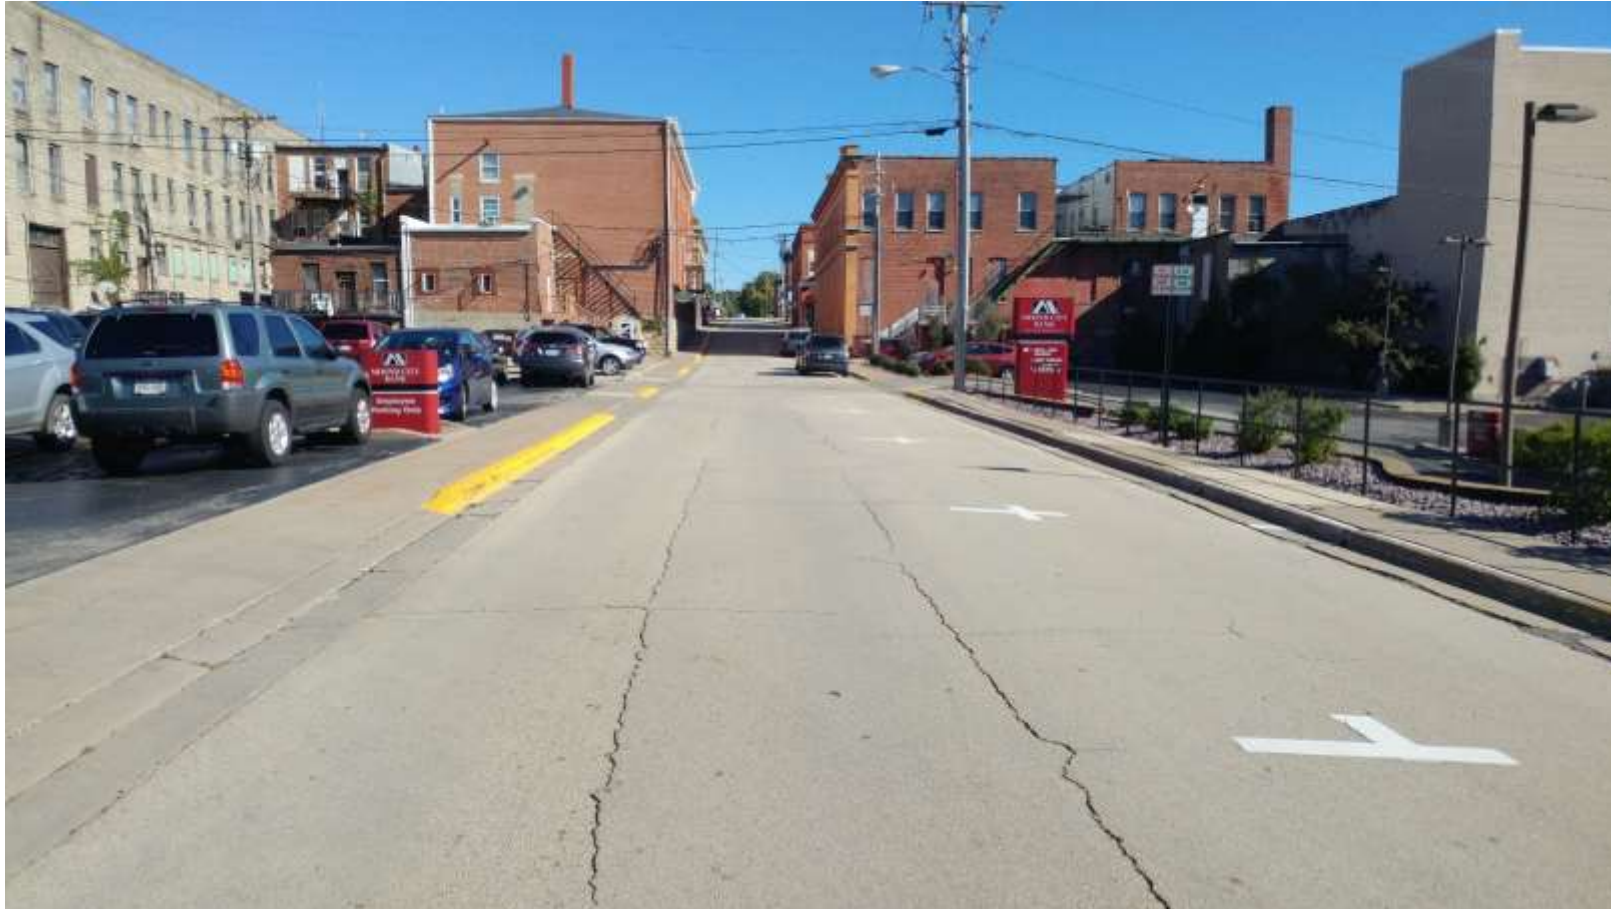
- After Photo: September 2016– full reflective cracking, no sealing, ride fair

- Excellent longevity on low volume street at approximately PASER 4. 2015 rating – PASER 5
- Has served 14 years with no maintenance – double expectations!
- In recent years Platteville has budgeted approximately \$200,000 for Thin Overlays.
- There are 2 cases that are looked at for Thin Overlays
 - PASER 5 streets for preservation. Expect 10 years + on low volume streets
 - PASER 3 streets as Band-Aid. Expect 4 – 5 years. This delays need for full street reconstruction to spread out reconstruction budget.
- Caveats:
 - Higher volume/higher truck use shortens life
 - Used in 2006 on State Highway 80 as wedge course in wheel path ruts. Expected to reconstruct in 2008. Project was delayed twice and reconstructed in 2012. Wedges failed in 2010.
